BRITTLE FRACTURE AND STRUCTURAL FAILURE OF  
THE LIBERTY SHIPS DURING WW-II (A)

The spectacular failures of many welded ships during the early years of World War II created a major engineering emergency. The failures involved the loss of both ships and lives, at a cost to the nation of \$50 million. Approximately 5000 welded merchant ships were constructed; of these, over 1000 suffered cracks in varying degrees. Some 190 ships sustained serious fractures. A dozen broke completely in two.

## A. First View of the Problem

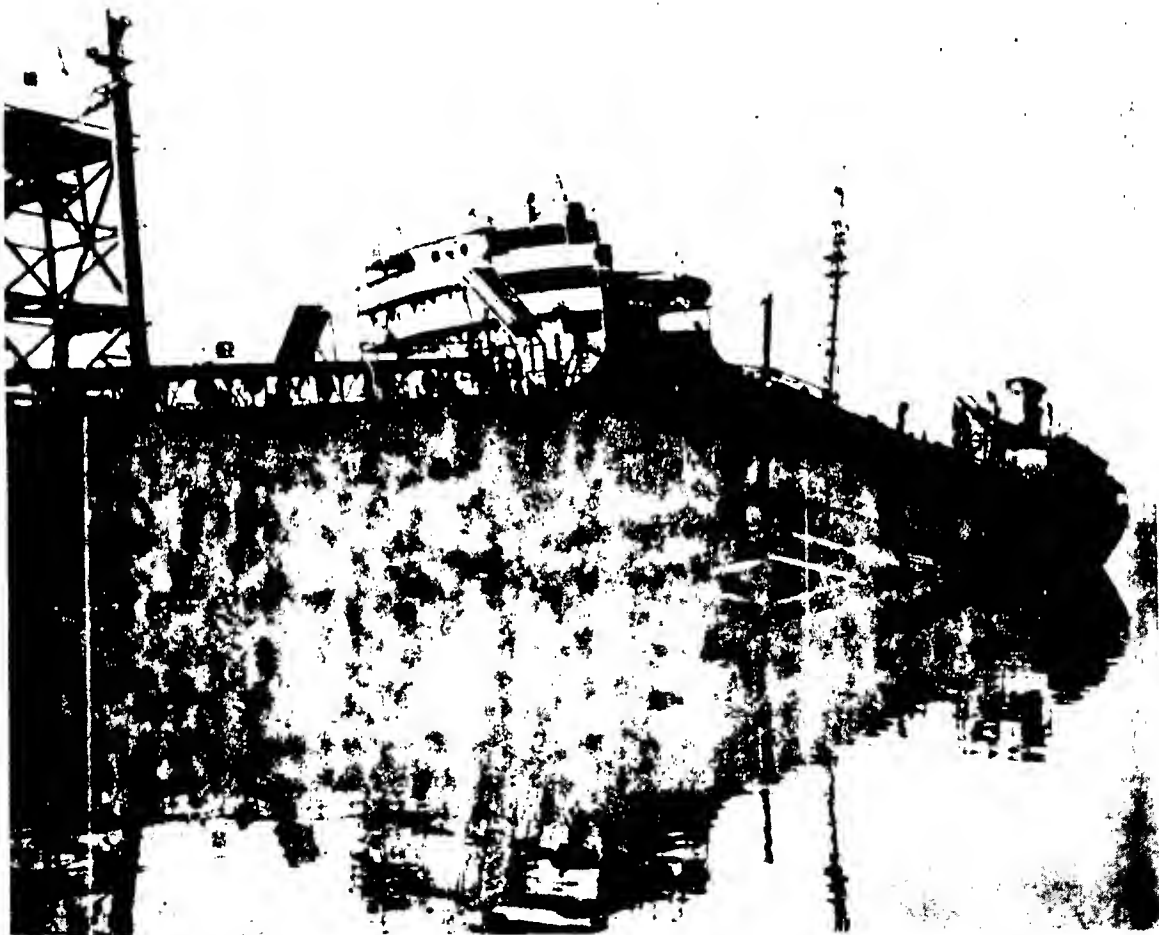
*S. S. Schenectady*

APPARENT STARTING POINT <b>The fracture started at the juncture of the fashion plate at the aft starboard corner of the bridge superstructure and the sheer strake</b>
GENERAL HISTORY AND DESCRIPTION OF FAILURE, INCLUDING KNOWN CONTRIBUTORY FACTORS: <p>Without warning and with a report which was heard for at least a mile, the deck and sides of the vessel fractured just aft of the bridge superstructure. The fracture extended almost instantaneously to the turn of the bilge port and starboard. The deck side shell, longitudinal bulkheads and bottom girders fractured. Only the bottom plating held. The vessel jack-knifed and the center portion rose so that no water entered the hull. The bow and stern settled into the silt of the river bottom. Sounding taken around the vessel eliminated the alleged possibility of the vessel having grounded amidships due to a drop in water level. A slight earth tremor was alleged to have occurred at the time of the casualty. The steel of the sheer strake was slightly below specification in yield point and ultimate strength. The deck stringer was low in yield point. Both steels were notch sensitive at low temperature, but there is no existing specification for this characteristic. The welds between the fashion plate and the sheer strake and between the sheer strake and stringer plate were found to contain defects.</p>

CLASSIFICATION OF FAILURE <b>Broke in two</b>

<b>Vessel repaired and put in service.</b>
Signed (Name and Title) <b>See reverse side for loading details.</b>

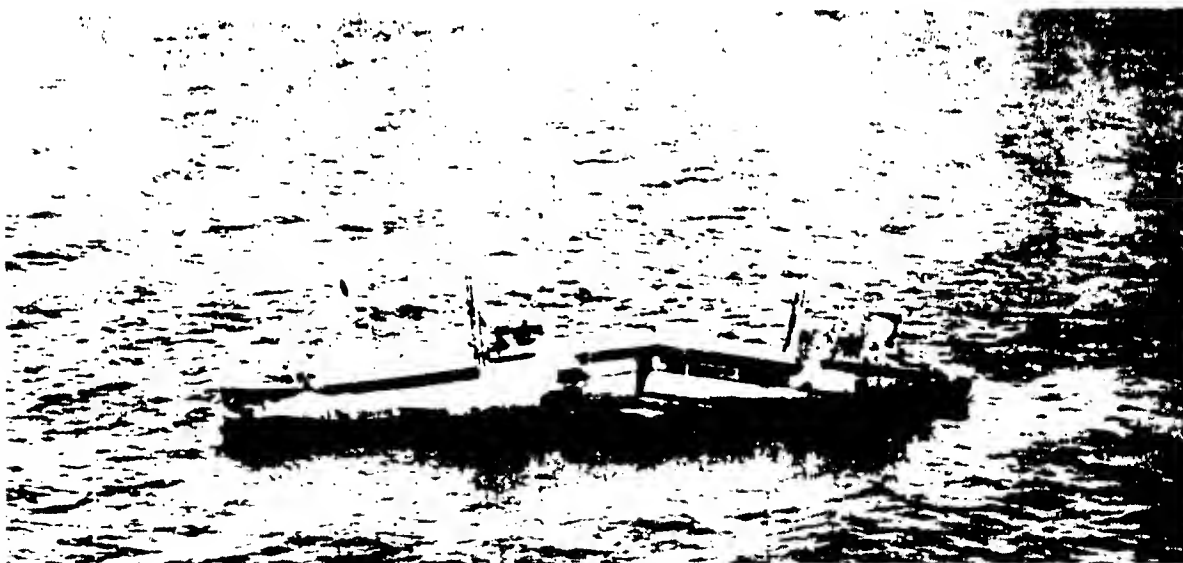
S. S. Esso Manhattan

APPARENT STARTING POINT <b>The fracture started in a butt weld between plates A-9 and A-10 at the crown of the deck.</b>
GENERAL HISTORY AND DESCRIPTION OF FAILURE, INCLUDING KNOWN CONTRIBUTORY FACTORS: <p>With a sound described variously as a thump, thud, bang, crash or explosion, the fracture ran across the deck in way of #6 tank, and down both sides, progressing to the bilge port and starboard. The vessel jack-knifed and the bow dug under an oncoming wave. The crew abandoned in the boats and were picked up by the USCG KIMBALL. The bottom fractured later and the two portions drifted apart. Subsequent examination and tests of the steel in the vicinity of the starting point and from each plate around the periphery of the hull near the fracture indicated that it met existing standards. The chemistry was normal for the class of steel. Impact and notch bend tests showed that much of the steel was sensitive to notches and low temperature. The butt-weld in which the crack started contained oxide, slag and porous areas.</p>

CLASSIFICATION OF FAILURE <b>Broke in two.</b>

At the time of the failure, the tanks were reported to be in the condition shown to the left. This was checked after the two portions had been towed into port. The vessel was taking ballast in accordance with the Navy schedule but due to damaged valves in #7 and #9 tanks which valves were to be repaired on the outbound voyage the schedule was not being strictly followed. The ends of the vessel contained proportionately more ballast. The uniform calculated stress in the crown of the deck in still water and in the condition noted is 12,300 lbs. per sq. inch.

<b>Repaired on drydock at Todd Erie Basin and returned to service.</b>
SIGNED (Name and Title) <b>See reverse side for loading details.</b>

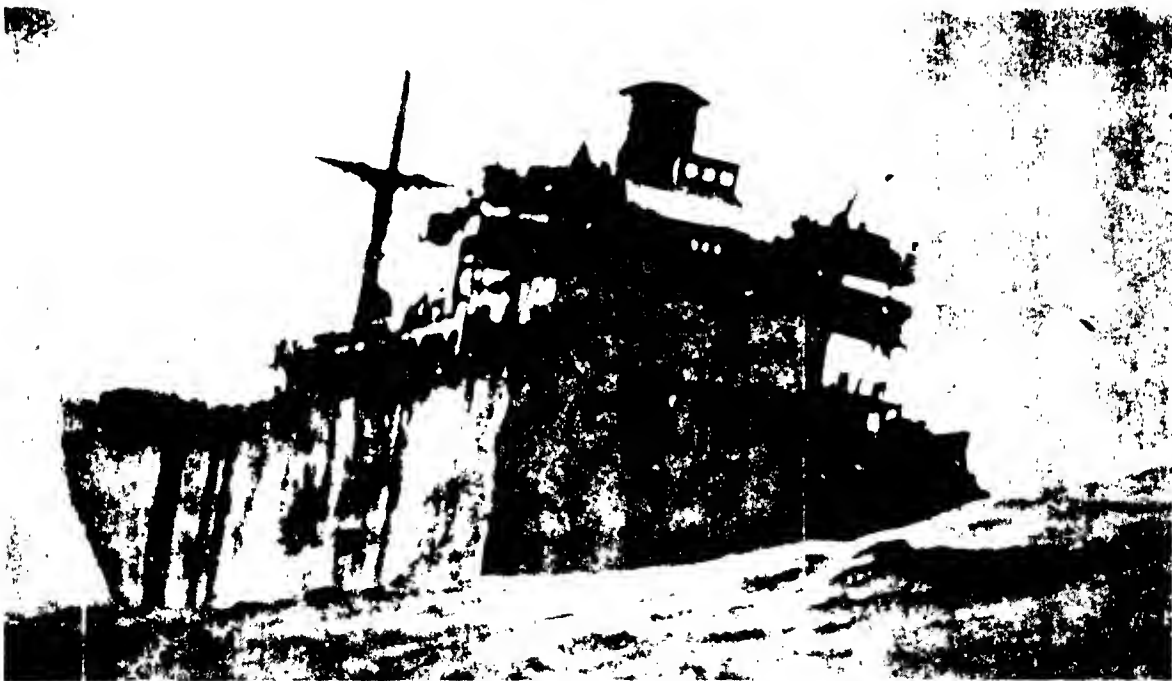
S.S. John P. Gaines

APPARENT STARTING POINT <b>Near Fwd. corners #3 hatch between Frs. #74 and #75.</b>
GENERAL HISTORY AND DESCRIPTION OF FAILURE, INCLUDING KNOWN CONTRIBUTORY FACTORS: <p>At about 2200 on 23 November, 1943, loud noises were heard but the source could not be located in the dark. At about 0241 on 24 Nov., 1943, an exceptional sea known locally as a "freak" or "sneaker" struck the port bow, curled around the stem, and boarded near the forward gun. The fracture which had apparently commenced during the night immediately propagated. It appears that the vessel broke partially as it passed either over or between swells and the following swell completely broke off the forward end. All crew and passengers were on the after end. Survivors were picked up by U. S. Army Transports except for 10 men, including six soldiers in one lifeboat, which was lost.</p>
CLASSIFICATION OF FAILURE <b>Broke in two</b>

On the basis of the loading shown to the left, indicating the condition at the time of departure from Dutch Harbor, bending moment calculations were made. The uniform calculated stress in the crown of the upper deck when on a standard wave with crest amidships is 15,600 lbs./in.<sup>2</sup>

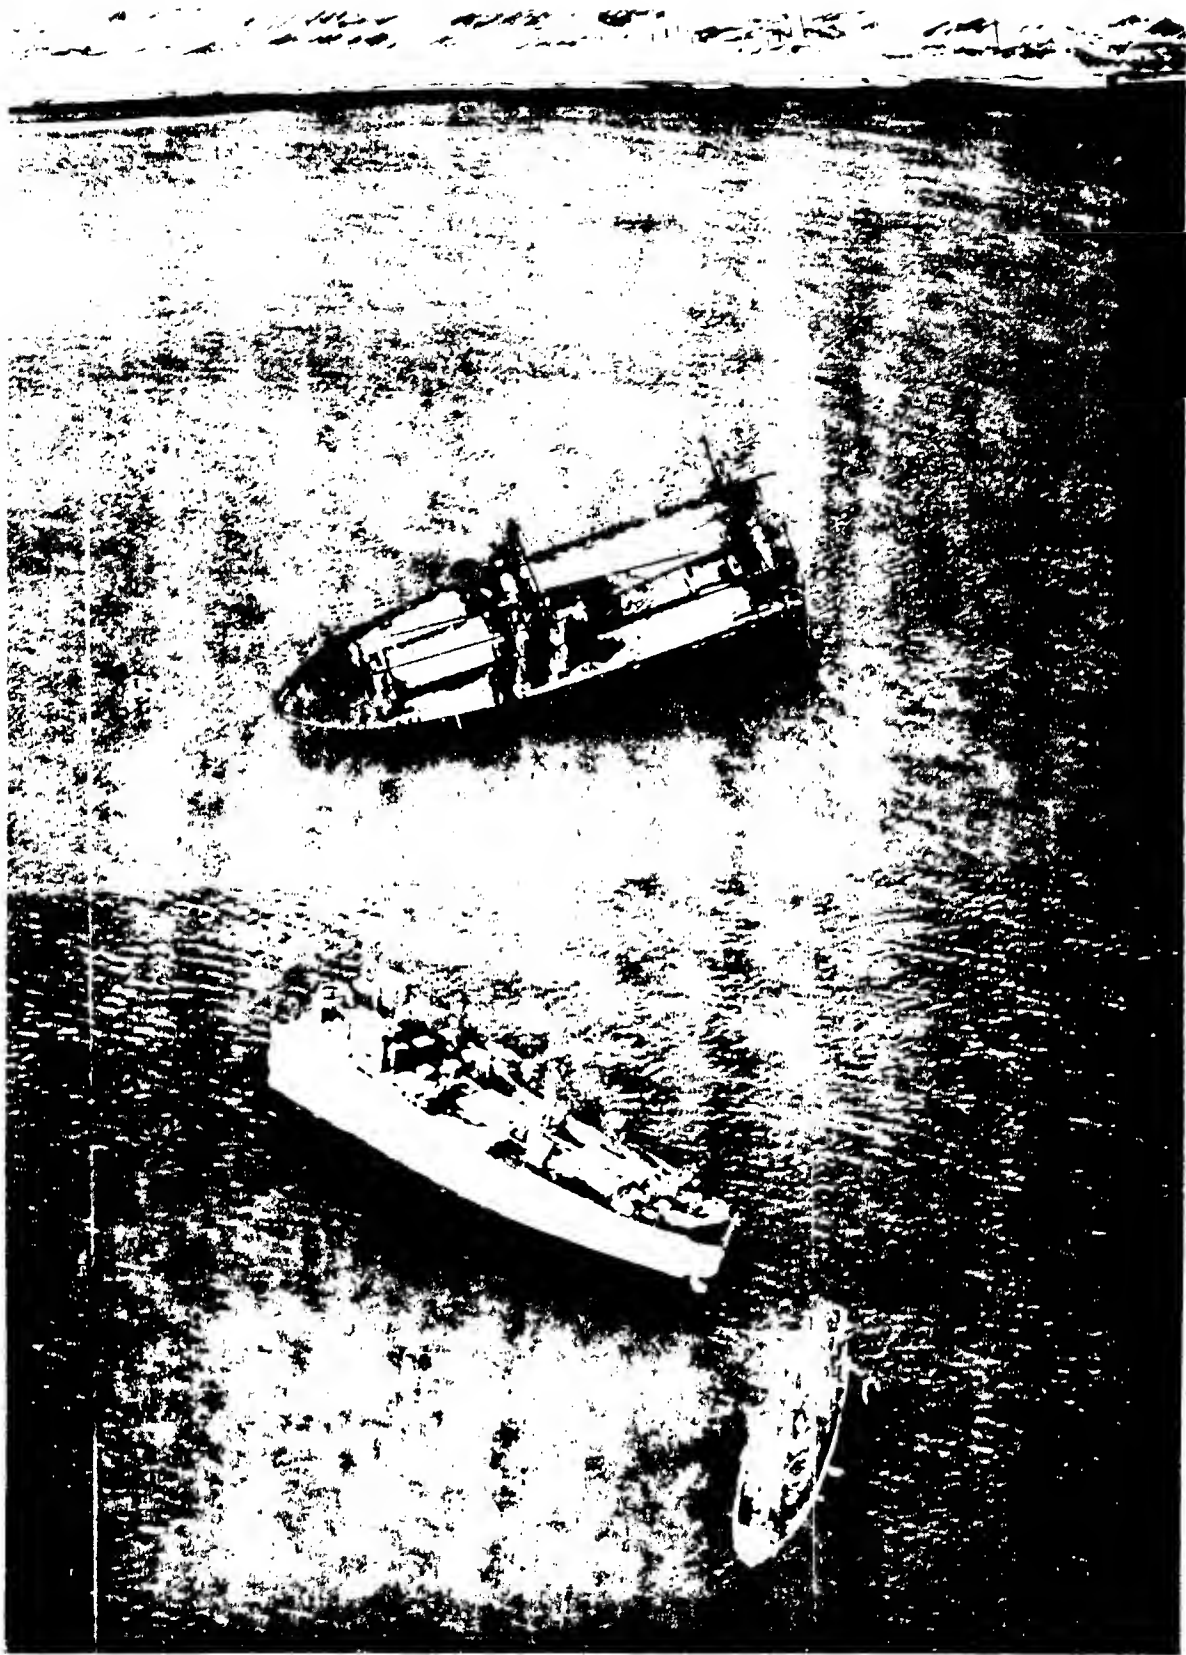
*S. S. Valery Chkalov*

APPROXIMATE STARTING POINT <b>The cracks which finally broke the vessel started exactly in the forward corners of #3 hatch port and starboard.</b>
GENERAL HISTORY AND DESCRIPTION OF FAILURE, INCLUDING KNOWN CONTRIBUTORY FACTORS: <p>The vessel departed from Sovetskaya on 1 Dec., 1943, in ballast. Gales and heavy seas were encountered after departure. At noon on 11 Dec., 43, a loud report was heard and three cracks were found, one on the port side at Fr. #74, one on stbd. side at Fr. #74; and one on the stbd. side at Fr. #76. The port side crack extended from the hatch corner across the deck and down the shell to the bilge. The stbd. crack at Fr. #74 was in the side shell from the sheer strake to the tween deck. The stbd. crack at Fr. #76 ran down the side shell from the sheer strake halfway down the tween decks. The vessel was taken in tow by the tug "Joseph Stalin" but at 2206 on 13 Dec. she broke completely in two. Both portions were taken in tow by U. S. Navy tugs and brought to anchorage. The crews did not abandon ship. Ballasting details will be made available by the USSR in the near future.</p>

CLASSIFICATION OF FAILURE <b>Broke in two</b>

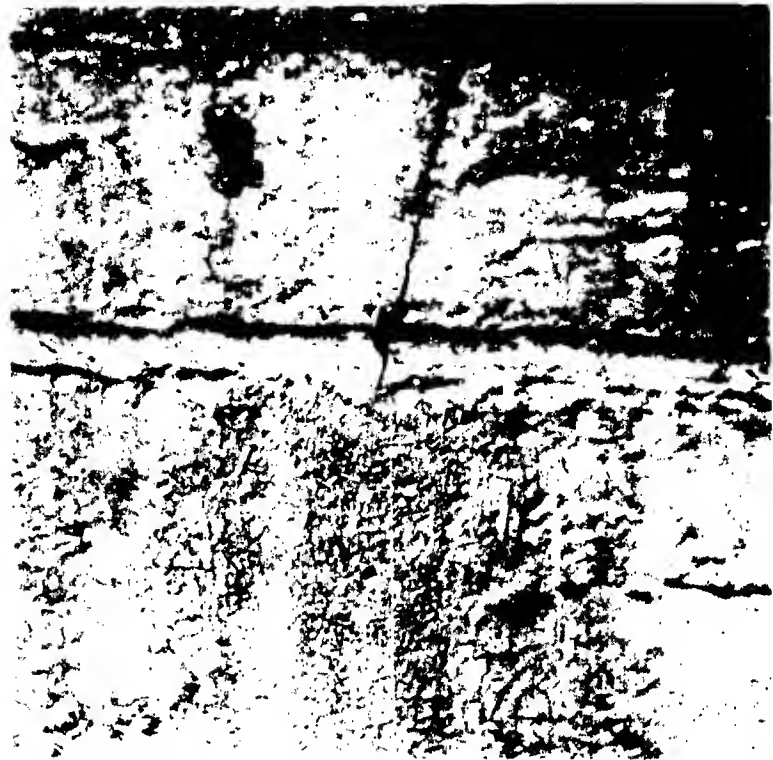
Fig. 5 Strain at the end of a shear fracture shown by cracking of the paint on the inboard side of the plate

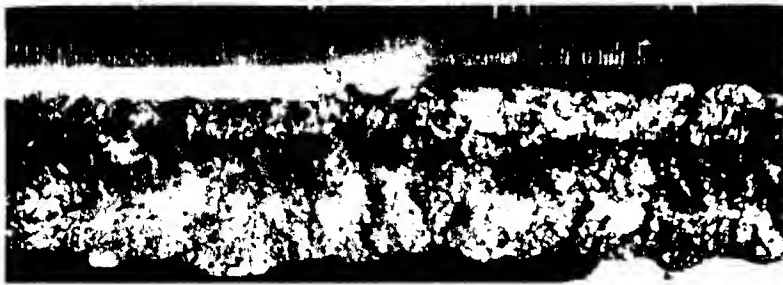
A faulty butt weld in a hatch side facing channel is shown in Fig. 9. Again (as in the weld shown in Fig. 4), the weld metal did not penetrate to the full thickness of the joint; the original flame-cut edge may be seen in the center of the photograph. The upper side of the weld had cracked at some previous time, probably during or shortly after the welding. When the part was painted the crack was covered over, and some paint penetrated the crack, as shown by the light areas near the top of the weld. After this vessel was launched, but before it was completed, there was a sudden complete failure of the strength deck, starting at this joint and at a similar faulty weld on the opposite side.<sup>14</sup> This costly failure might have been averted if, by better supervision and inspection, the initial crack in one side of the weld had been found and repaired before painting.

*Fig. 9 Faulty butt weld, showing poor weld penetration, in hatch side facing channel, NBS Ship No. 2, Type L6-N-B1*

Dark areas at center are original flame-cut edge of plate. Paint penetration in upper part of weld (light areas) indicates weld was partly cracked before painting. Subsequent failure of weld led to complete fracture of strength deck.  $\times 1$ .

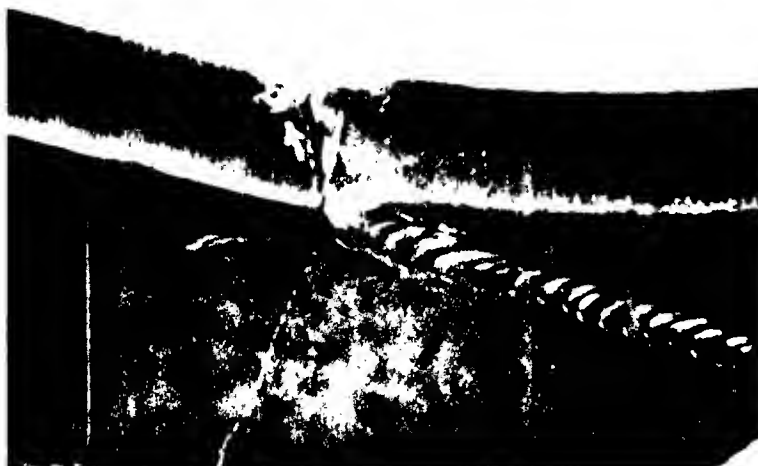
*Fig. 11 Source of fracture shown in Fig. 10, viewed from inboard and above. Arrow shows arc crater and globule of weld metal on flame-cut edge of sheer strake plate, adjacent to toe of fillet weld*

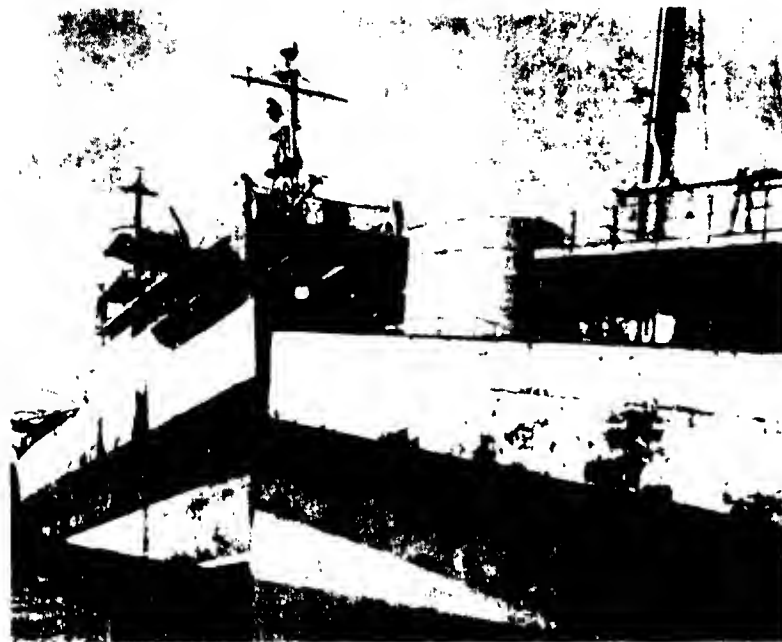
Fig. 15 Tanker that broke in two at dock, viewed from port side, looking forward

The bending moments that contributed to the origin of the fracture are indicated by the positions of the two parts of the vessel. NBS Ship No. 52, Type T2-SE-A2. (U. S. Coast Guard Photograph.)

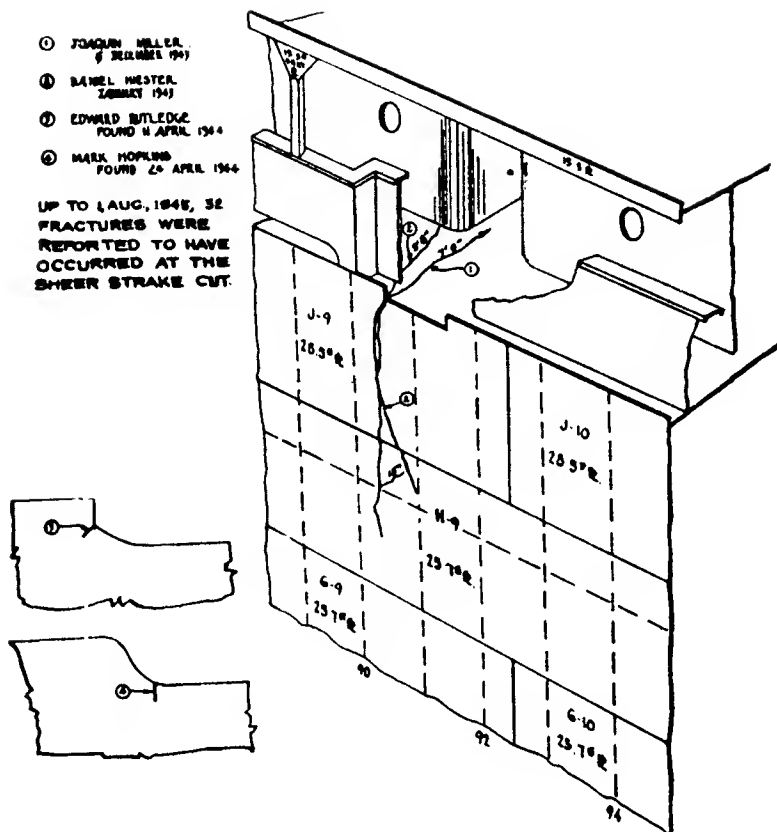
Fig. 22—Liberty Vessel; Composite Sketch of Fractures at Cut in Shear Strake for Accommodation Ladder

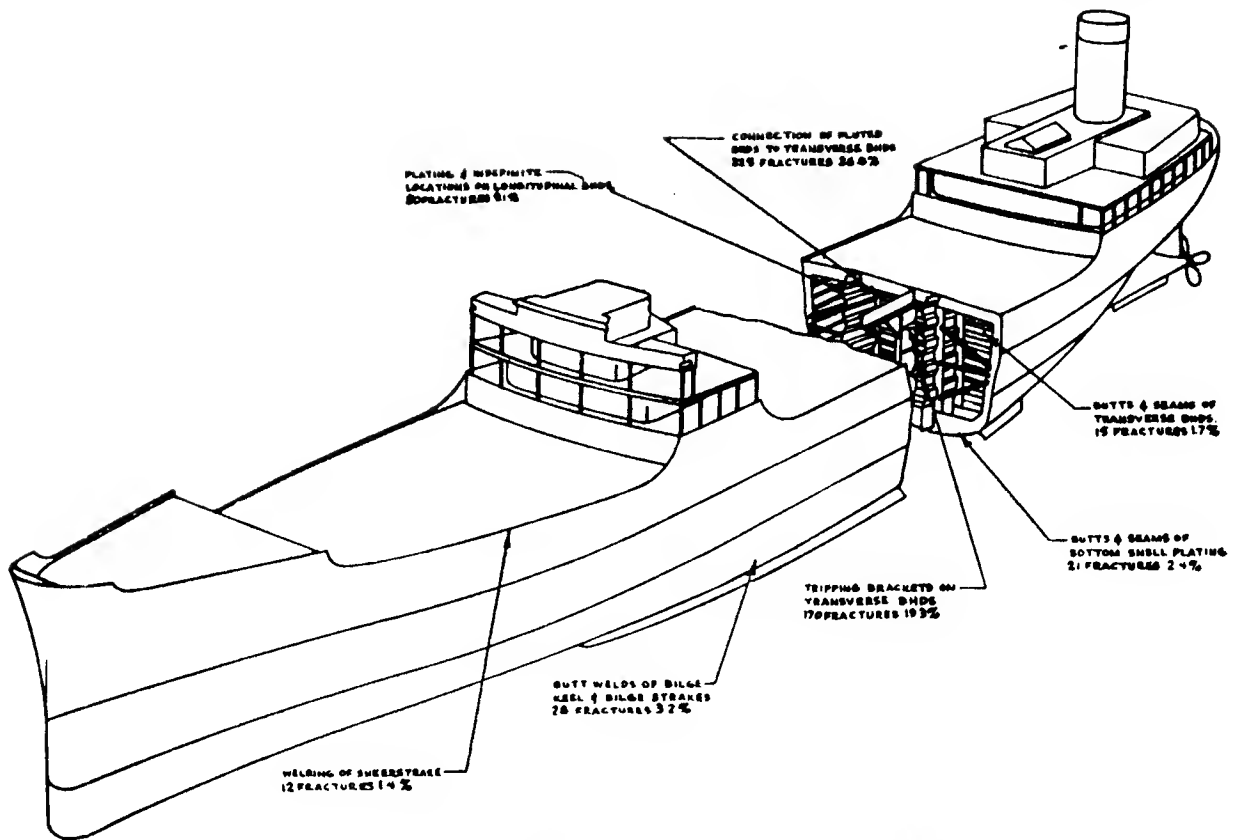
Fig. 25- T2 Tankers; Details with Abnormal Frequency of Fractures

These data include 883 fractures of known origin, occurring before 1 Aug. 1945. Fifty-six other fractures of indefinite origin were reported.

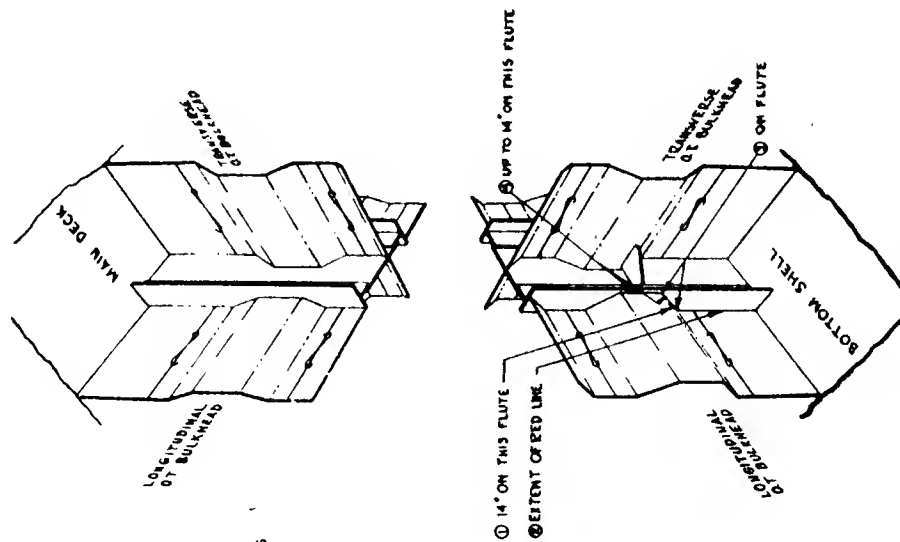
Fig. 26—T2-SE-A1 Type; Composite Sketch of Fractures; Connection of Fluted Longitudinal Bulkhead to Transverse Bulkheads

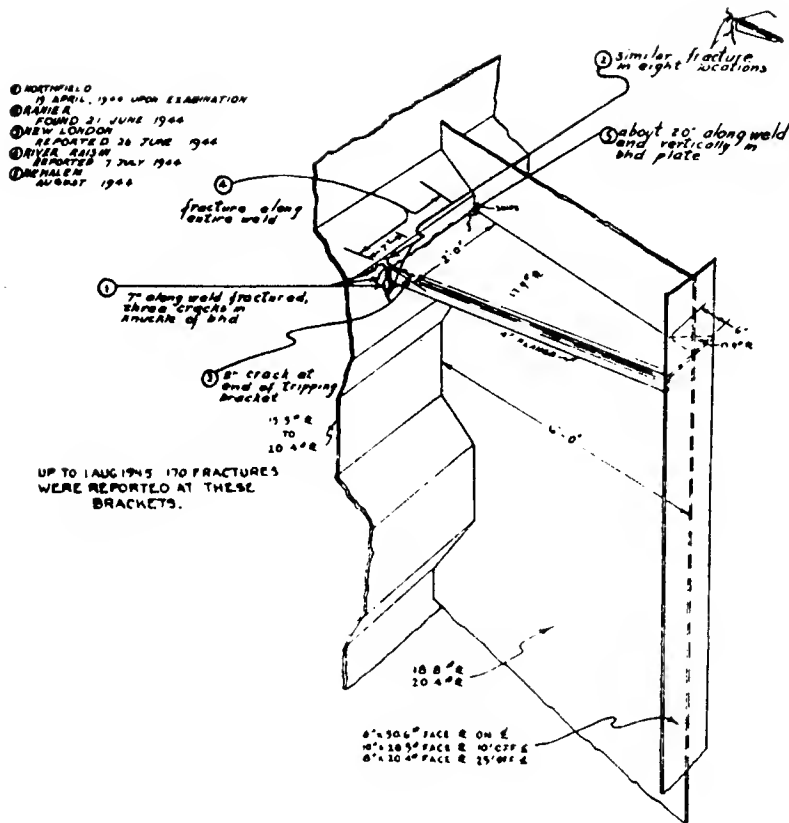
Fig. 27—T2-SE-A1 Type; Composite Sketch of Fractures; Tripping Brackets of Bulkhead Stiffeners on Transverse Bulkheads

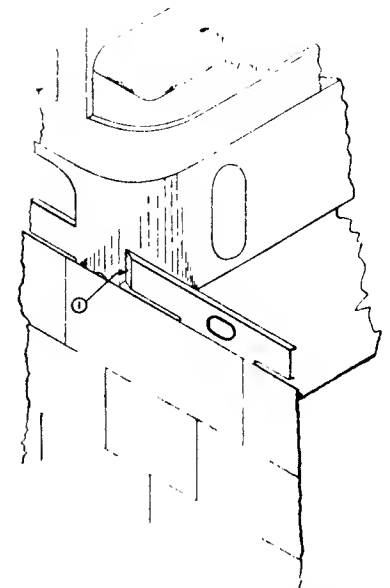
Fig. 28—Victory Ships; Typical Bulwark Fracture at Forward End of Deck House

(1) Lewiston Victory 23 Jan. 1946; forward end of P. & S.; aft end P. & S. (2) Grinnell Victory before Aug. 1945; forward end, port only; aft end P. & S.

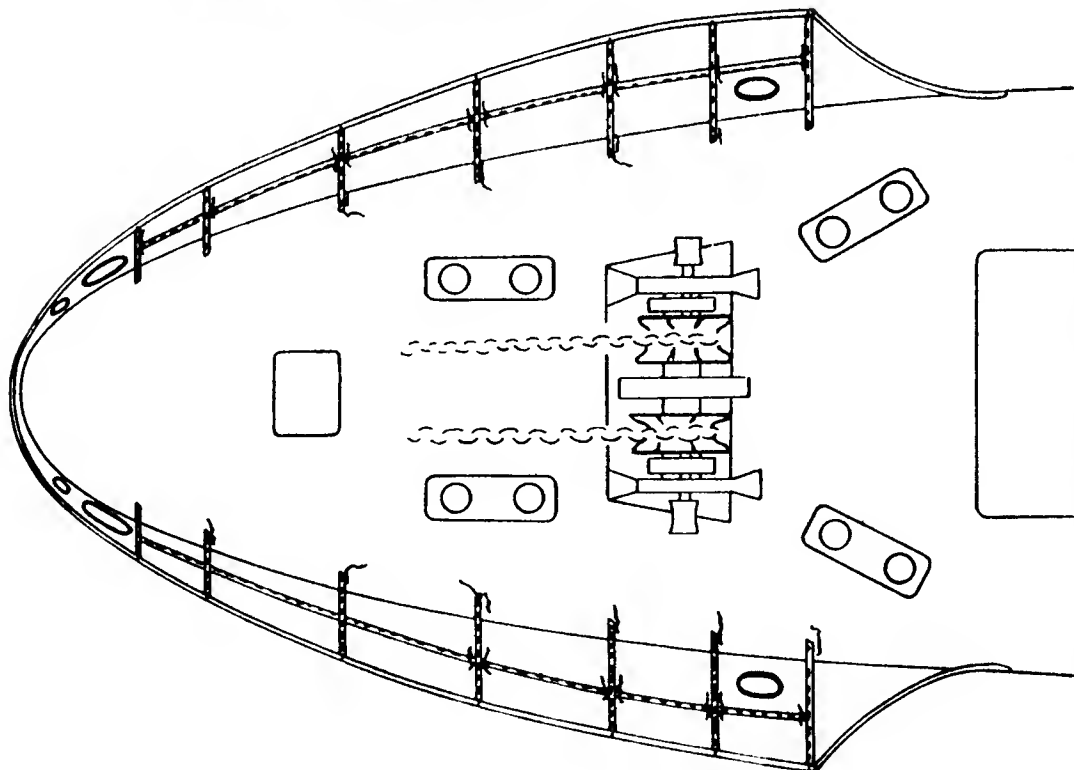
Fig. 29—Victory Ship, Foc'sle Dk., Showing Typical Deck Fractures in Lewiston Victory Which Occurred on 23 Jan. 1946

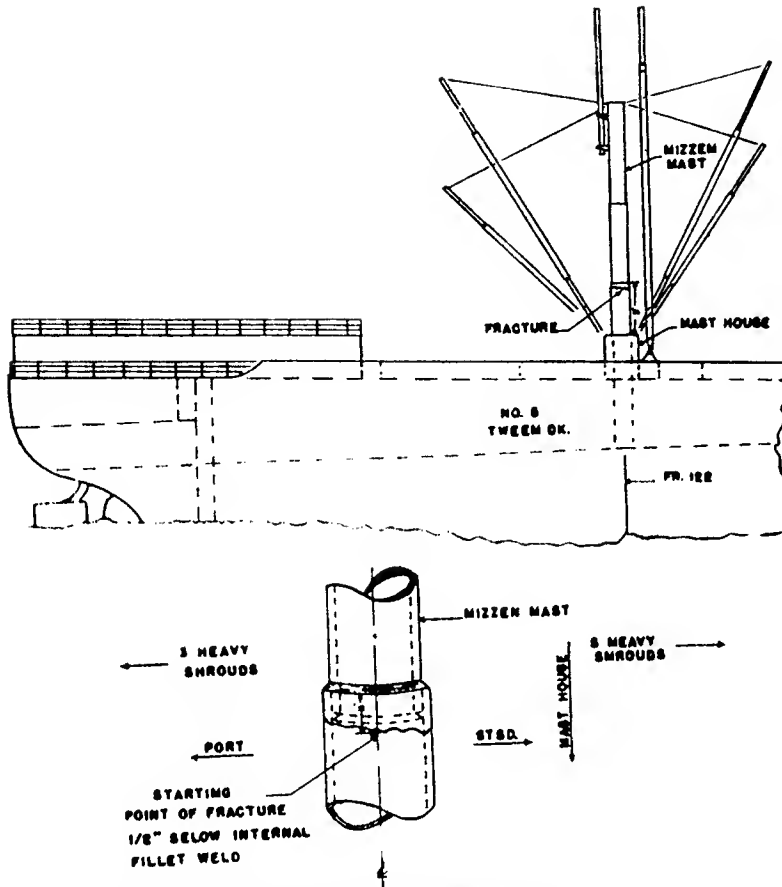
Fig. 30—Victory Ships Showing Fracture of Mizzen Mast of *Mahanoy City Victory* Which Occurred on 24 Jan. 1946

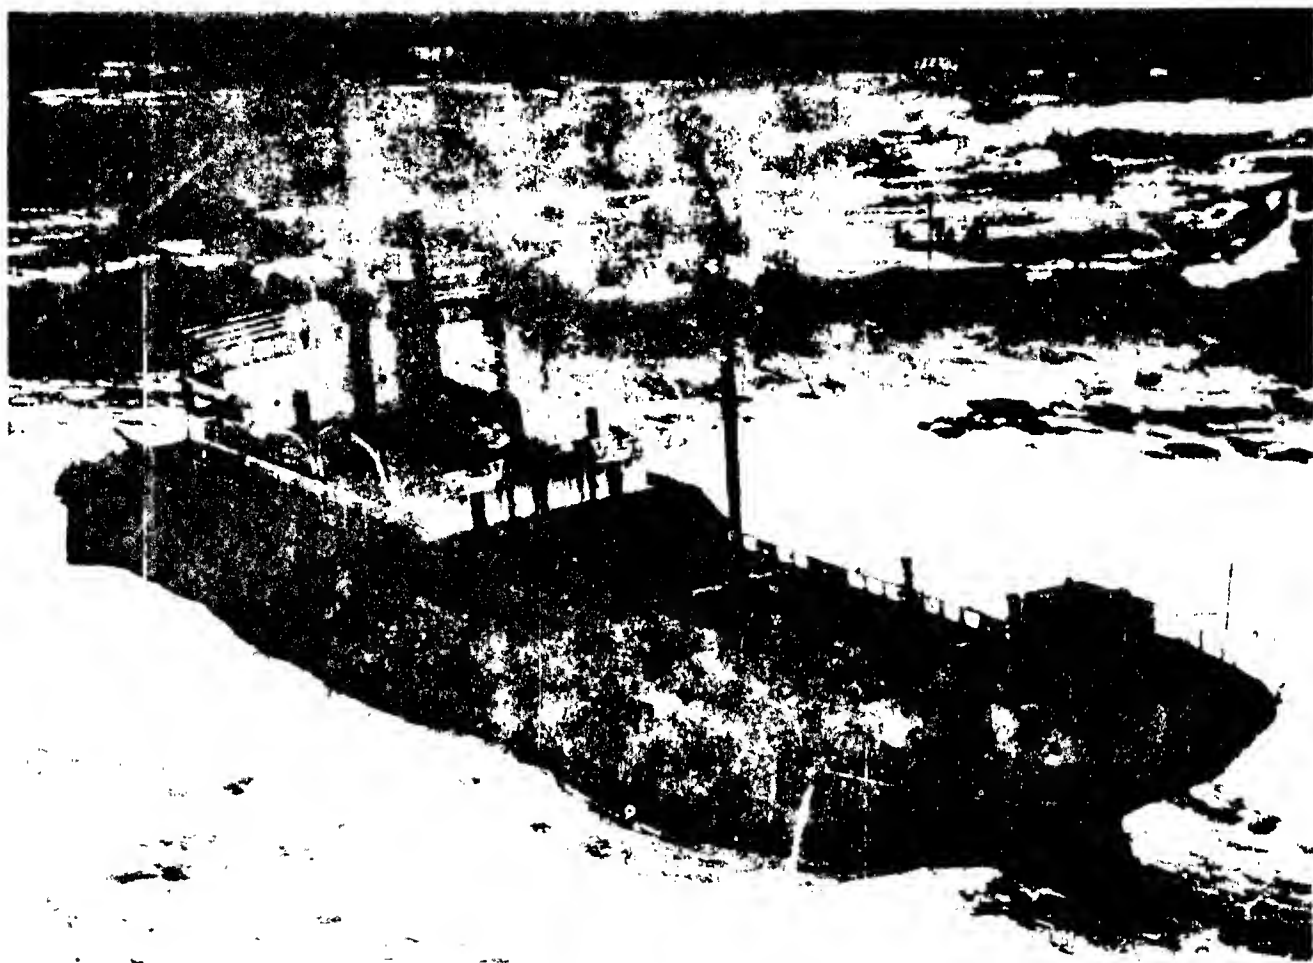
Damaged freighter *Oakey L. Alexander* grounded at Cape Elizabeth, Maine.

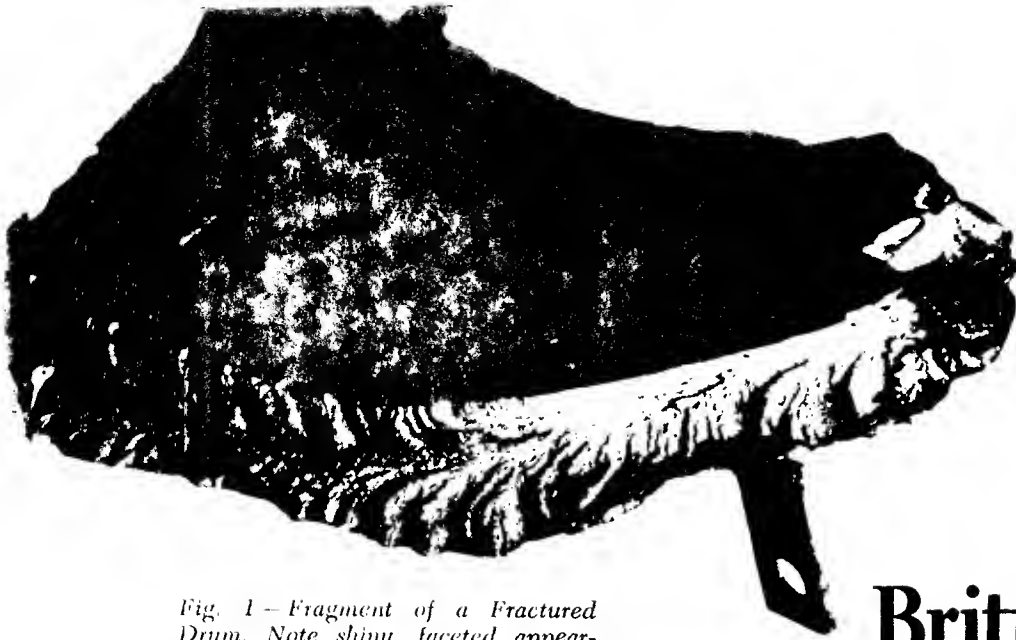
*Fig. 1—Fragment of a Fractured Drum. Note shiny, faceted appearance, sometimes called the chevron pattern. Apices of herringbone markings point to the origin of failure*

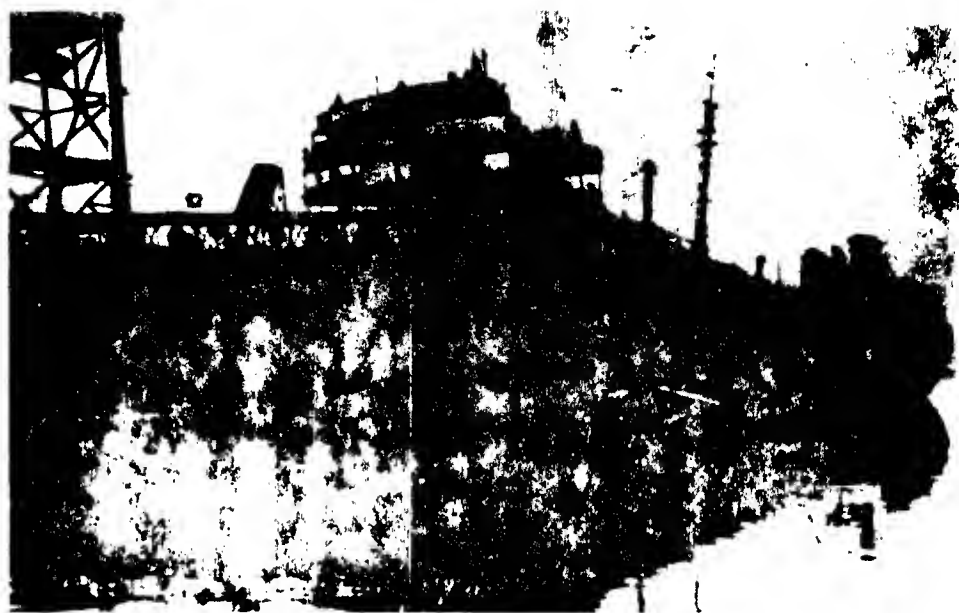
Fig. 3 — T-2 Tanker Which Broke in Half at Dockside
